## **Cobblestone Pavement Discovered During Archaeological Investigations at the Bimeler House in Zoar Village**

Chandler S. Herson, Linda Pansing and Bill Pickard,  
Ohio Historical Society

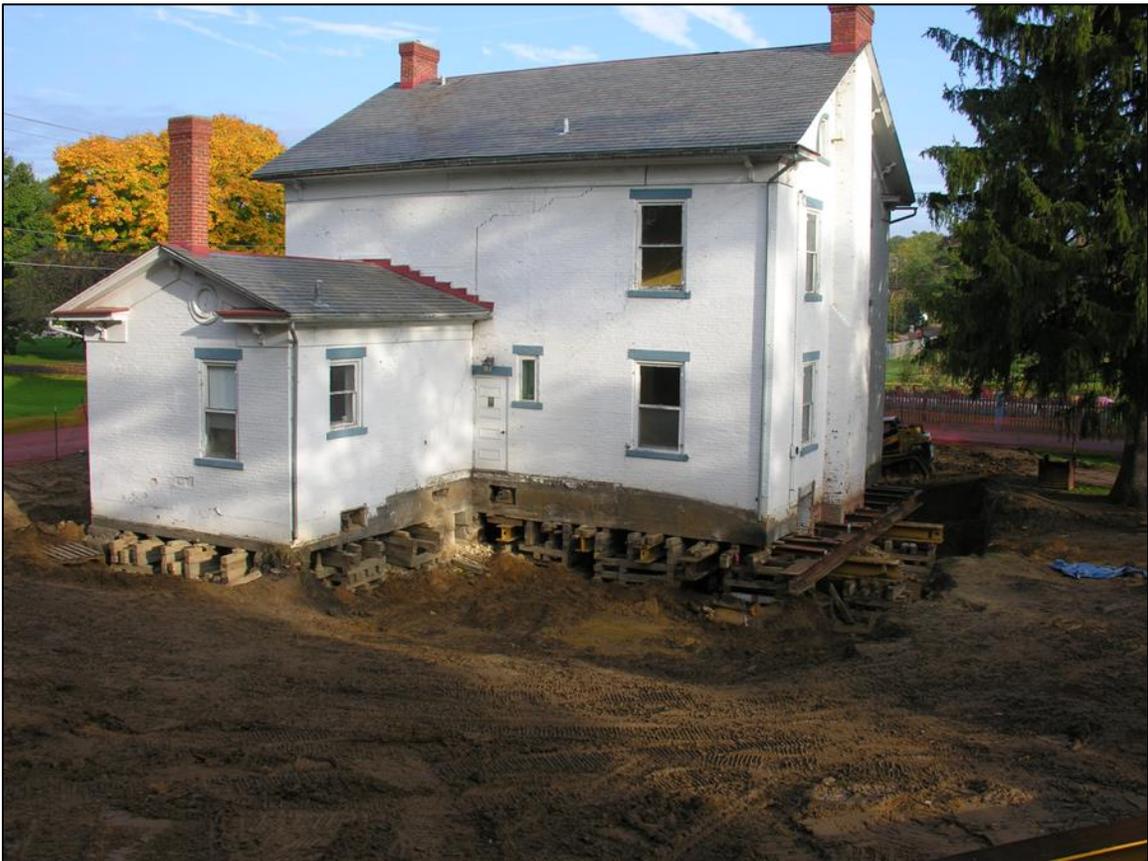
**Figure 1. Overview of lifted house, view to the north.**

The Bimeler House was severely damaged by floods which occurred in the winter of 2005. Subsequent soil coring and other structural investigations determined that soils under the house foundations had a limited bearing capacity and that a complete foundation replacement would be required in order to preserve the building and return it to its pre-flood condition (Herson, Pansing, Pickard and Lepper 2013). The house would need to be mechanically lifted and its foundation rebuilt before lowering the house back into place (Figure 1).

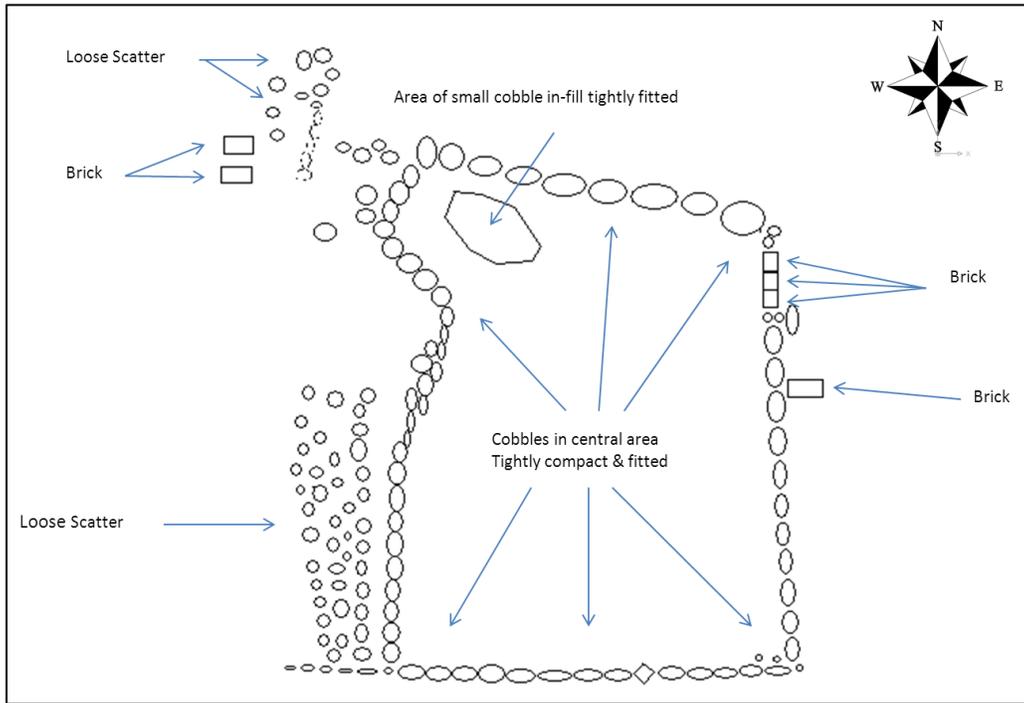
**Figure 2. Cobblestone feature.**

During monitoring, a previously unknown cobblestone feature was exposed near the southeast corner of the house (Figure 2). The cobblestone feature was trapezoidal in shape with loose scatters of stone located to the northwest and west of the feature. The cobblestone feature was 3 m N-S by 2.65 m E-W. The cobbles range in size from between 25 x 15 cm to 8 x 10 cm with the in-filled cobbles measuring 3 x 4 cm. The feature resembled the floor of some structure, but no postmolds were observed to confirm this. Numerous nails and glass fragments were associated with the feature, however.

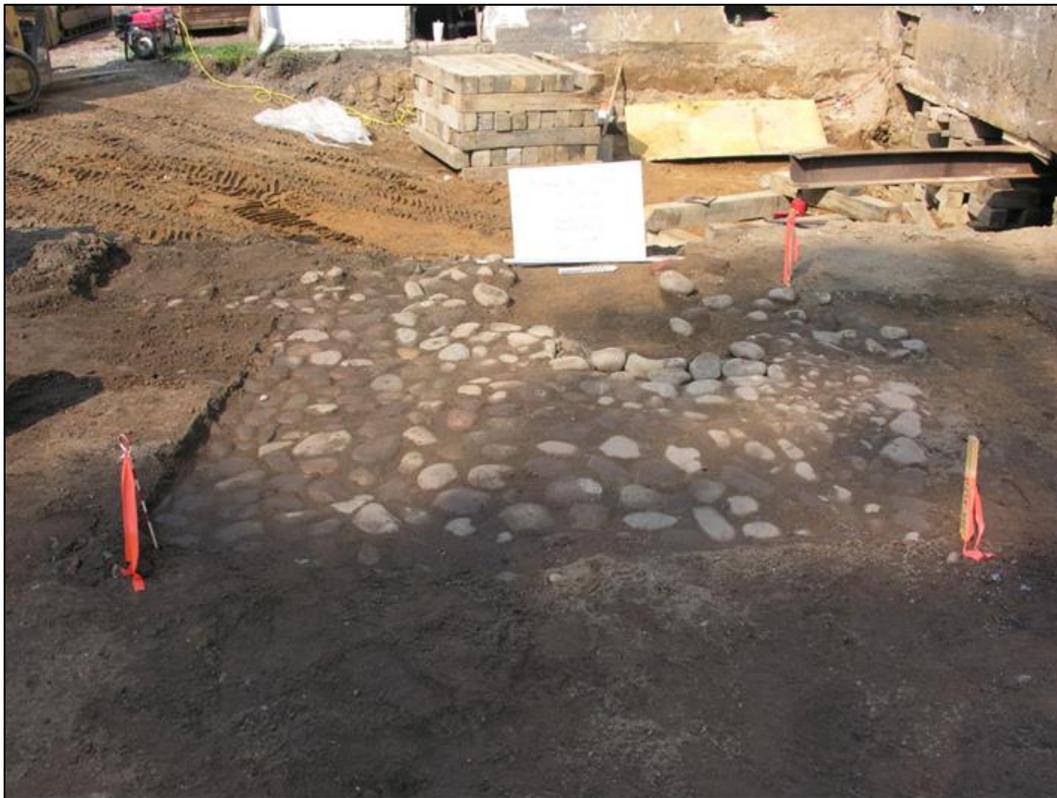
**Figure 3. Cobblestone feature, west profile.**

The entire feature was removed during the preparation of the site for raising the Bimeler House from its foundation. Since the pavement may have belonged to the Zoar period, we have recommended that it be restored and further historic research be undertaken so that this feature may be included in future interpretive programs at the Bimeler House (Figure 3).
