The Ringler Dugout Revisited

N'omi B. Greber, Katherine C. Ruhl, and Isaac Greber

Journal of Ohio Archaeology 2:16-29, 2012

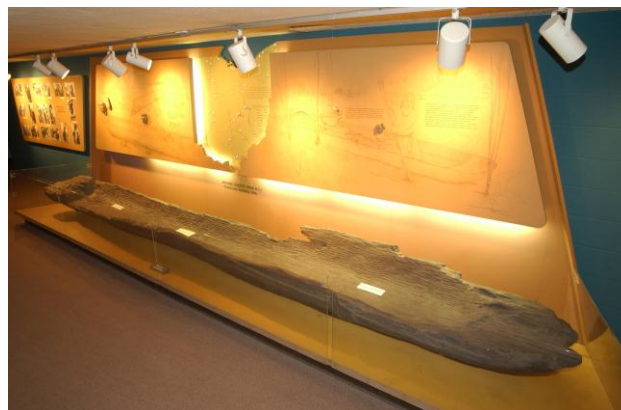
Figure 1. Cast of the Dugout on exhibit in the Ohio Pre-history Gallery, Cleveland Museum of Natural History. The text on the white cards points out tool marks and burned or burnished areas on the floor of the craft.

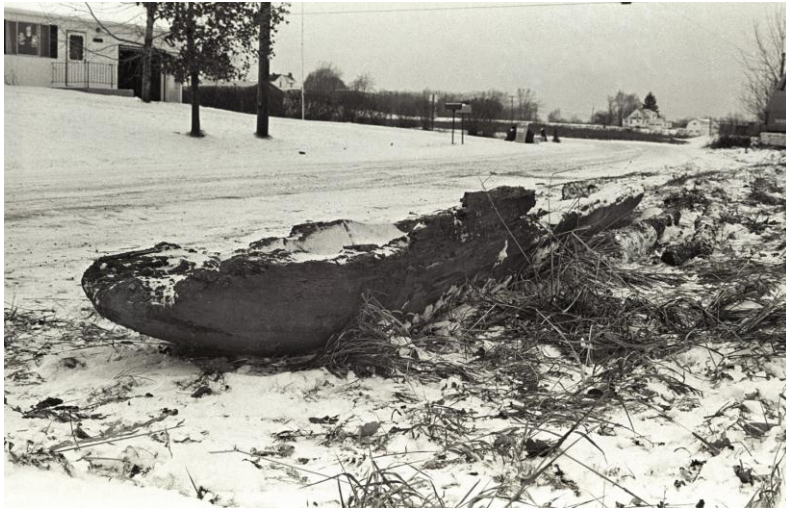
Figure 3. Dugout in the field, 1976.

Savannah Lake lies at the headwaters of the Vermillion River in Ashland County, Ohio, near the divide between the drainage systems of the Great Lakes to the north and the Ohio River to the south (Figure 2). On November 30, 1976, as Harold Slessman was dredging in the lake, removing peat with a clam-bucket scoop, he brought a large wooden object to the surface. Fortunately, he realized that he had found a dugout canoe, rather than simply an old log. He informed the Ringler family, who owned the property, and they in turn contacted Dr. David Brose at the Cleveland Museum of Natural History. Luckily a cold snap froze the Dugout and protected it from drying out on the shore of the lake (Figure 3). Within

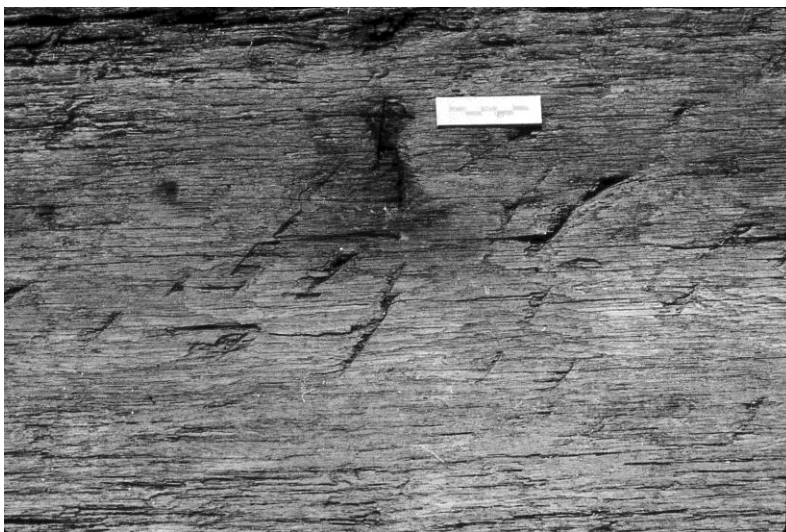
Figure 4. Tool marks in the interior of the Dugout (CMNH Archaeology Archive Slide AT3270).

The Dugout was shaped from a large white oak log. The overall length is 690 cm, width 110 cm, and depth 60 cm. The interior depth was approximately 36 cm when the sides were intact. Both tool marks and scorched areas are preserved in the interior (Figures 4 and 5), showing that the Dugout was hollowed out by alternately burning and scraping, a prehistoric technique that has been described by early European observers. A flat platform was retained on either rounded end. Other features still visible are worn areas in the interior bottom, presumably where people sat or kneeled to propel the craft. On the edge of the highest part of the gunwale still preserved, a small semi-circular notch might have served as an oarlock. More problematic is a deep notch lower down in the opposite exterior side (Figure 6), perhaps also used to assist in paddling or poling the craft. The hull is elegantly shaped, with tapered bow and stern (Figure 7).

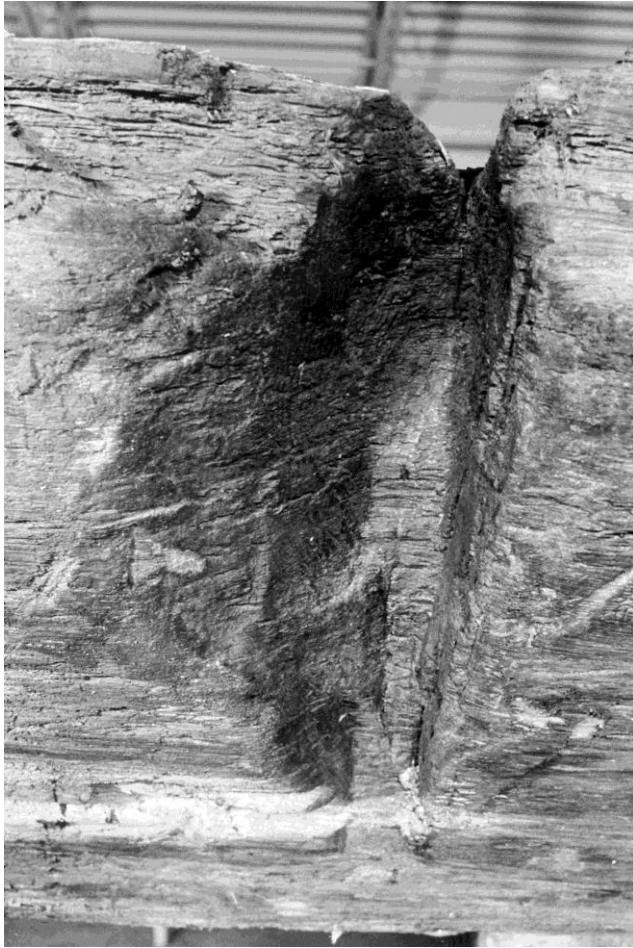
Figure 6. Deep notch in the exterior of the Dugout (CMNH Archaeology Archive Slide AT3269).

Figure 14. The notch on the gunwale after completion of the preservation process, photograph taken February 2004. Compare to Figure 6.

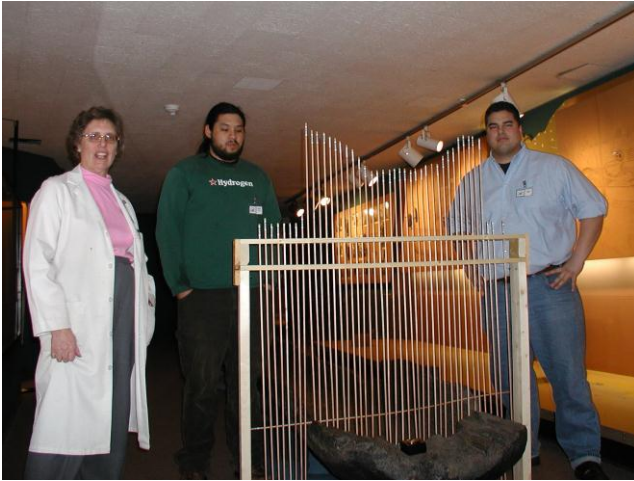
Figure 8. Katharine Ruhl, Evan Harris, Joseph Molner with measuring device and dugout cast in 2003.

measurements were made on the cast, not on the dugout itself. The first group of students, Evan Harris and Joseph Mohner, designed and constructed a special measuring device for this purpose. They were assisted in their measurements by Katharine Ruhl, who had been instrumental in the preservation of the Dugout. A photograph of the students with Ms. Ruhl and with their measuring device is shown in Figure 8.

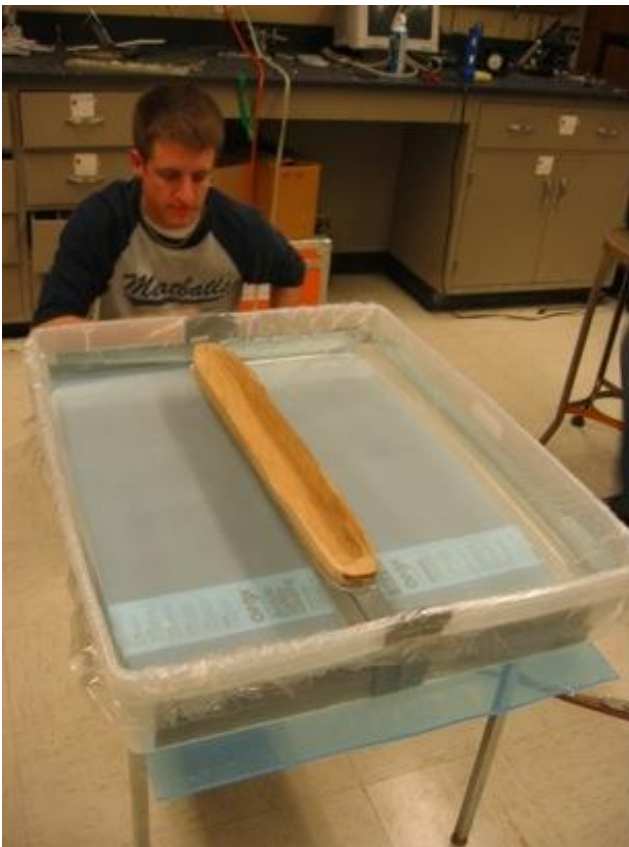
Figure 9. Model dugout in dynamic test tank at undergraduate laboratory, Dept. of Mechanical and Aerospace Engineering, Case Western Reserve University in 2004. Photo by William Wright.

Williams, and William Wright. They first designed and constructed a small pool suitably sized for observing and measuring the rolling motion of the model dugout. A photograph of the pool with the model floating in it is shown in Figure 9. Preliminary experiments were performed on motion of water in the empty pool in order to ensure that waves reflecting from the walls of the pool would not influence the

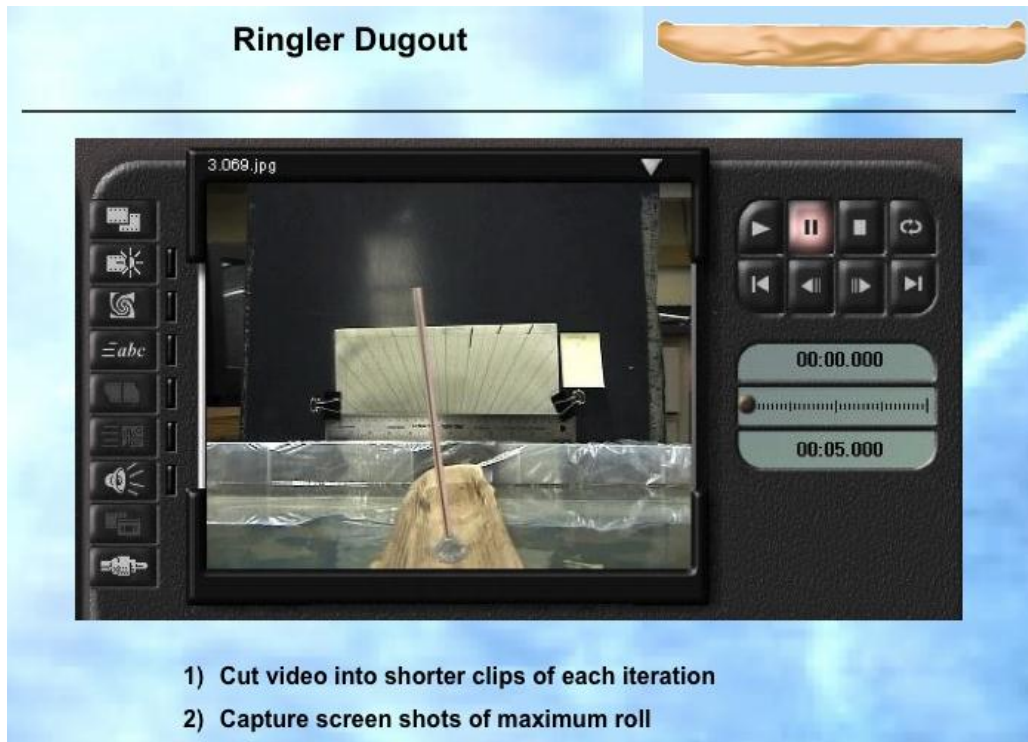
Figure 11. This photograph taken by William Wright shows the video equipment (on each side of the image) that was used to visually record changes in the rolling angle of the dugout under various loads. The center of the image is a still from the video showing the dugout and the needle arrangement for marking a roll angle. The entire video was played later and the angle readings recorded for use in calculating graphs such as the one in Figure 12.

The experiments were conducted by displacing the boat a given angle, then releasing it and observing and recording its rolling motion. The motion was recorded using a digital video camera, and the information was transferred to a computer using the software program MGI Videowave III. Measurements were made at rolling angles of 10, 20 and 30 degrees at each of the loading conditions, and all measurements were made several times to ensure that the data were repeatable and accurate. A photograph of the observation view as seen on the computer screen is shown in Figure 11. In all of the experiments the humans were in a position that would correspond to kneeling or being seated low in the vessel.

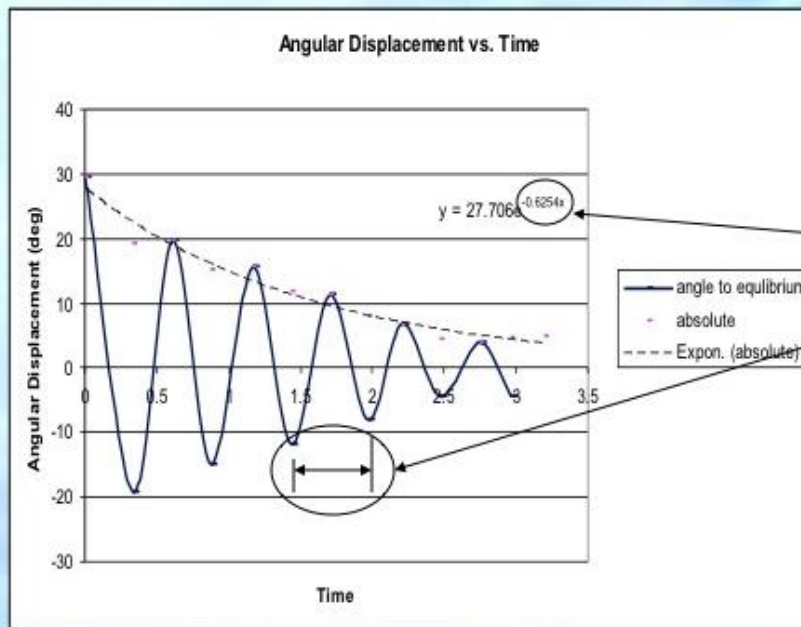
Response to Disturbance (30 degree)

- Exponential Decay Coefficient
- Period of Oscillation

Figure 12. Time history of rolling motion.

Figure 12 shows a sample graph of the time history of the oscillation after the boat is released from its displaced angle. From graphs such as this one we can obtain the period of an oscillation (that is, the time for a side-to-side swing) and the time it takes for the oscillation to subside. Table 1 presents the oscillation period and corresponding loading condition. The periods are averages over the set of displacement angles. The variation with displacement angle is at most 3 percent.

One sees that the empty boat has a significantly shorter oscillation period than the loaded boat, and that the longest periods occur with the three persons or with three persons plus cargo. The spread of periods for the loaded conditions is 4.3 percent of the maximum period; the empty boat period is 11.9 percent smaller than the maximum value. These times can be translated to corresponding times for the full

size vessel. The period of oscillation increases as the square root of the size, similar to the behavior of a pendulum. The maximum period for the full size boat would be 1.85 seconds, and the shortest period, that of the empty boat, would be 1.63 seconds. Boaters would tend to regard these times as slow rocking. The rocking subsides rather quickly. As one sees in Figure 12, the rolling angle decreases to about half its displaced angle in about two oscillations, and to about a third in four oscillations. These values do not vary significantly with loading.

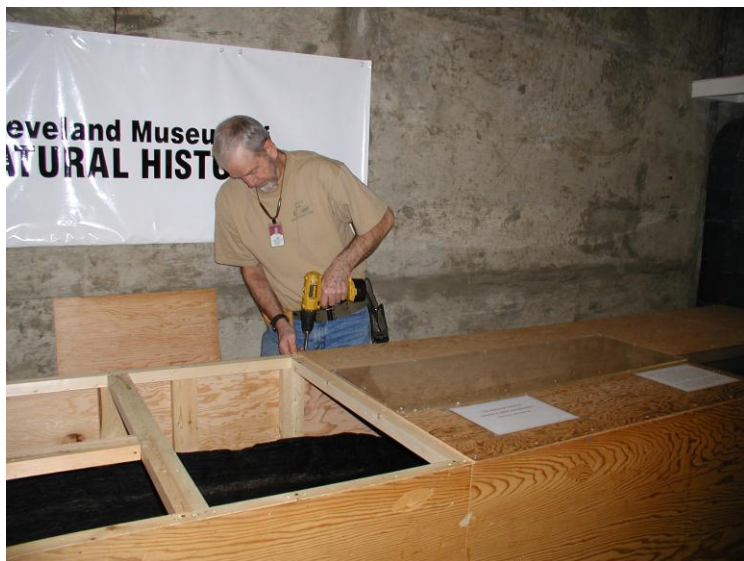
Figure 13. James Bowers, Archaeology Department, Cleveland Museum of Natural History installing the new clear plastic top in 2004.

In order to be able to show visitors the Dugout itself in its current case and location, in January 2004 the case was remodeled (Figure 13). Now the top of the sealed case is clear plastic that allows visitors to see the real Dugout. A folding wooden top covers and protects the plastic between viewings. While the case was open a close inspection showed that the preservation had gone well and the Dugout is stable. (Figure 14; compare to Figure 6). After all the wooden sides were removed in order to complete the remodeling, record photographs were taken for the archives and for future study.

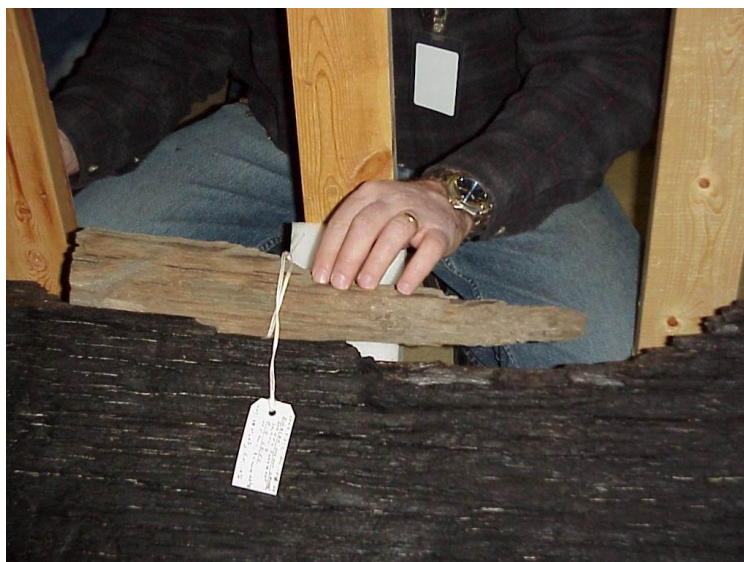
Figure 15. Air dried fragment (CMNH 9127C) next to canoe gunwale, photograph taken February 2004.

Seven fragments, assumed to be from the Dugout, are also stored in the case. Some of these had been used to test conservation methods. One that had been air dried (CMNH 9127C) appeared to be a good fit as part of the original side of the boat (Figure 15). A small piece of this fragment was sent to Beta Analytic Radiocarbon Laboratory to obtain an additional radiocarbon assay of the Dugout’s age. Two runs were reported: Beta-189203A, conventional radiocarbon
